## Historic District Commission

City of Kalamazoo

**Tuesday, October 17, 2023**

1. 837 Davis - Addition (Rear Addition) PPZ23-0028  
*Year Built:* 1900  
*Style:* Greek Revival  
*Historic District:* South Street - Vine Area
2. 161 E Michigan- Alteration (Installation of Sign) PPZ23-0029  
*Year Built:* 1900  
*Style:* Commercial  
*Historic District:* Haymarket
3. 763 W Michigan- Alteration (Trim, window and door replacement) PPZ23-0030  
*Year Built:* 1926  
*Style:* Tudor  
*Historic District:* South Street - Vine Area

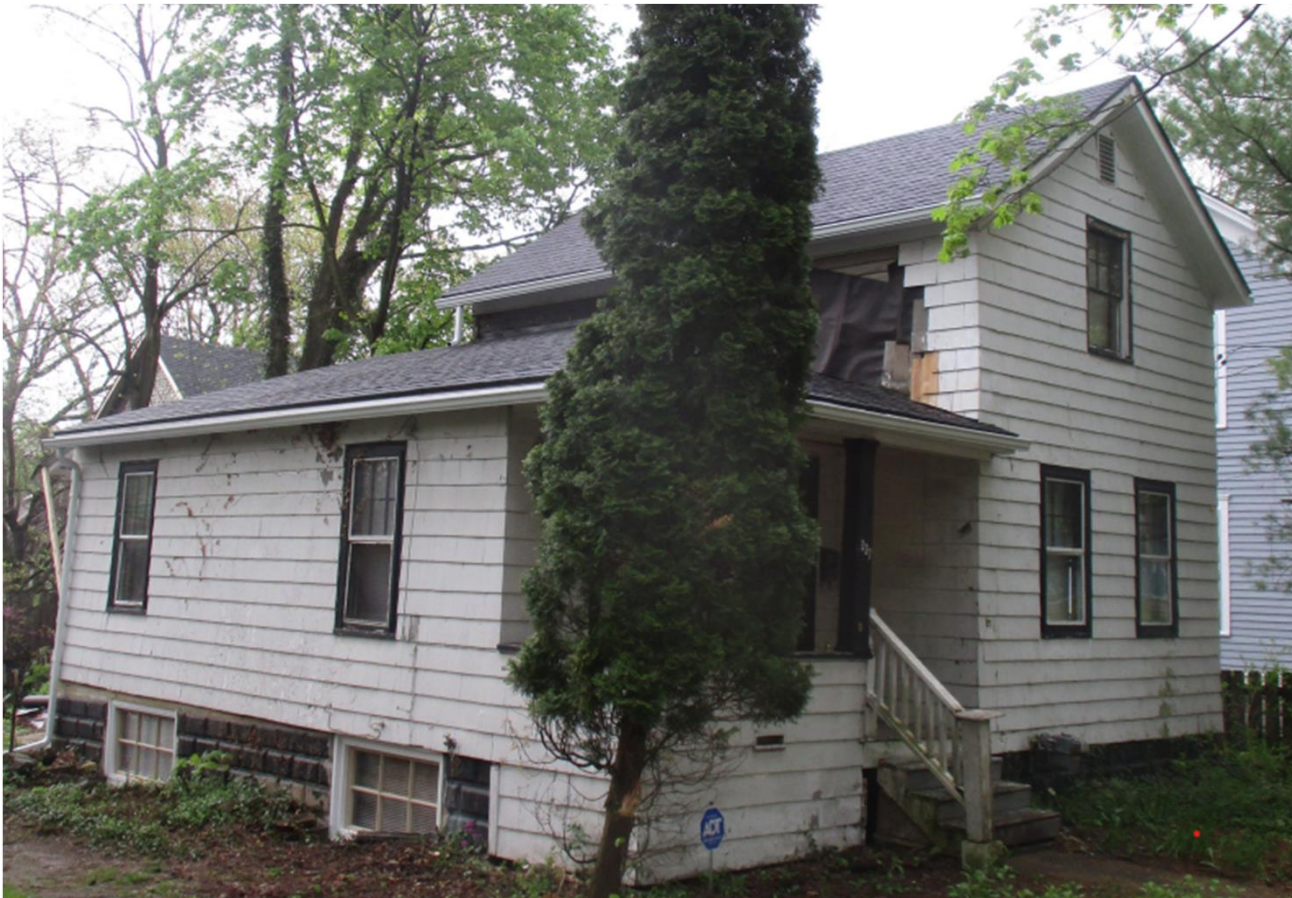
# Back View of House

Located in the Historic District. It needs to follow Historic Guidelines

A bedroom is needed on the main floor

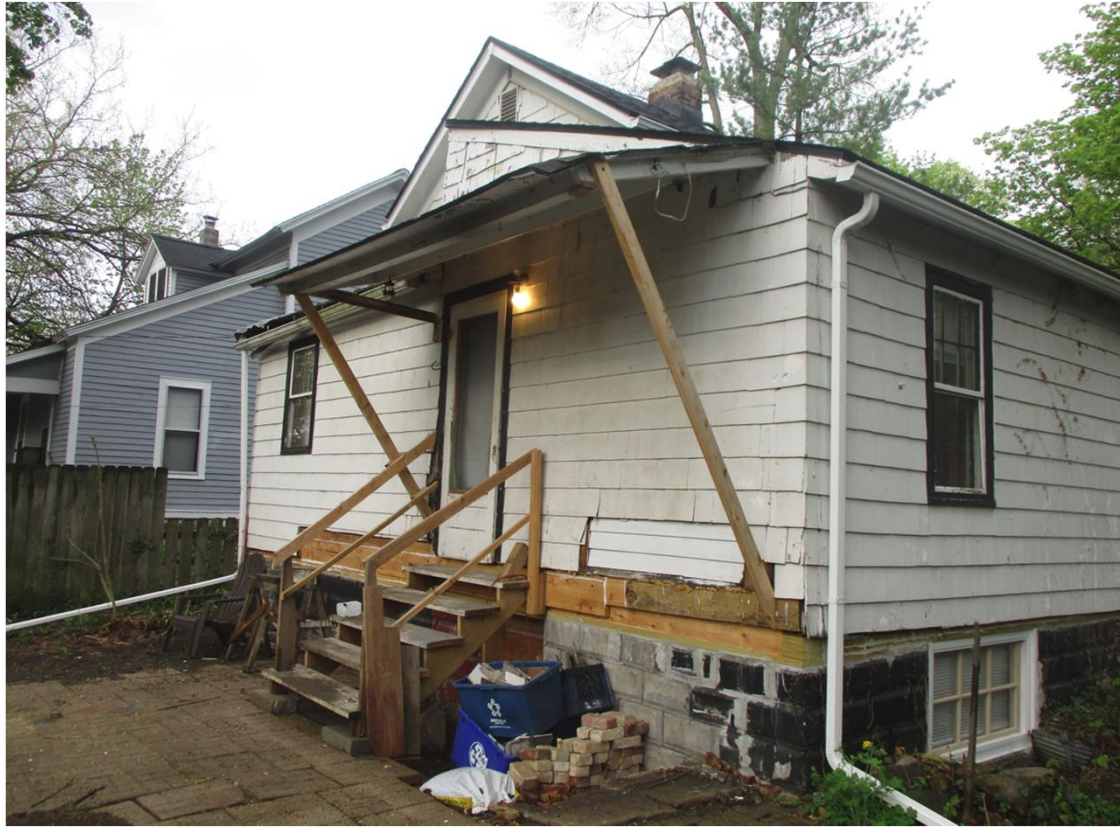
- Addition to extend 12 ft from the back by, 26ft., the full width of the house
- New Ledgers and Sill have been installed across the back of the house.

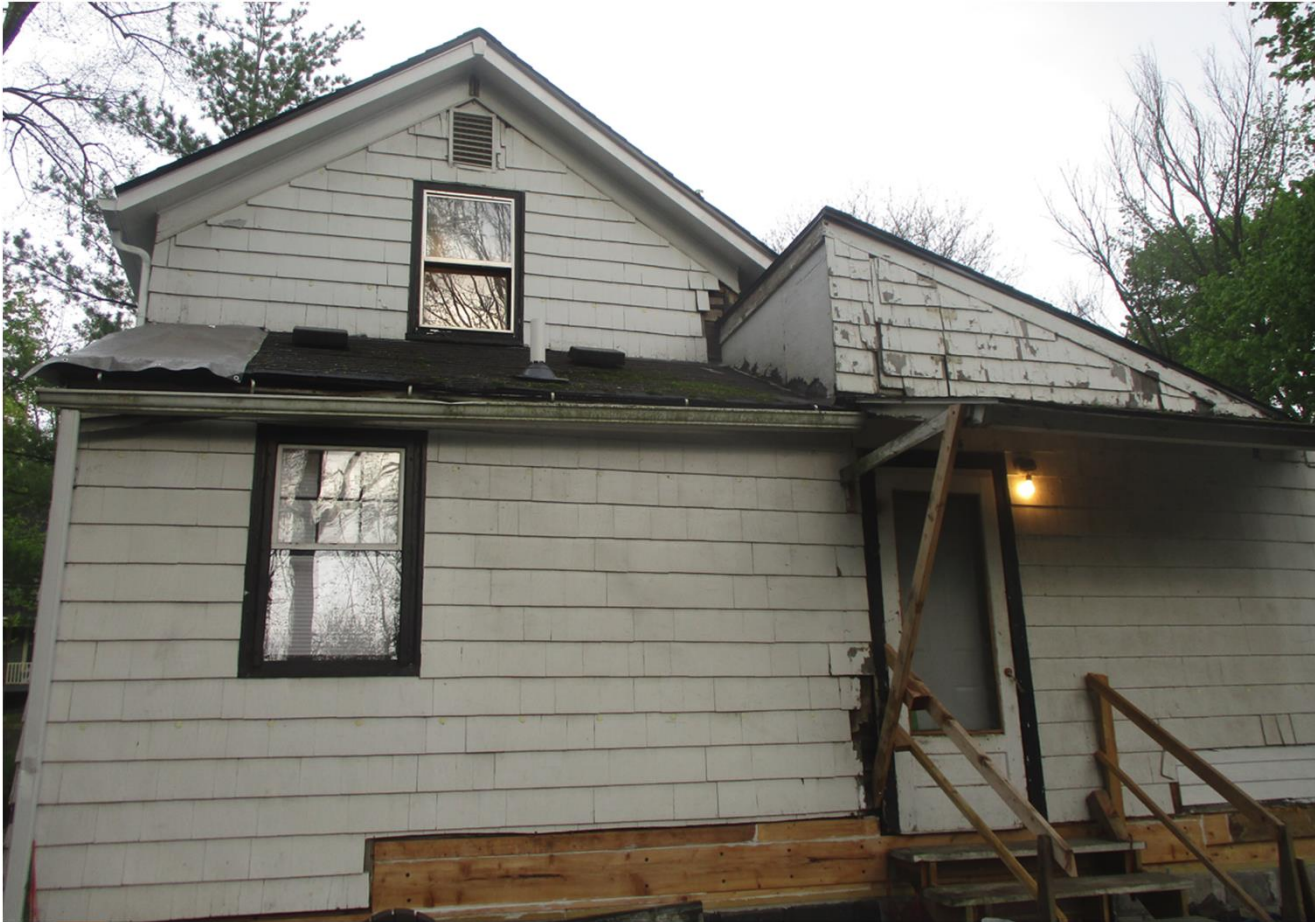
# Addition for 837 Davis Street

- Extend the second floor toward the back to the exterior wall. See also next figure

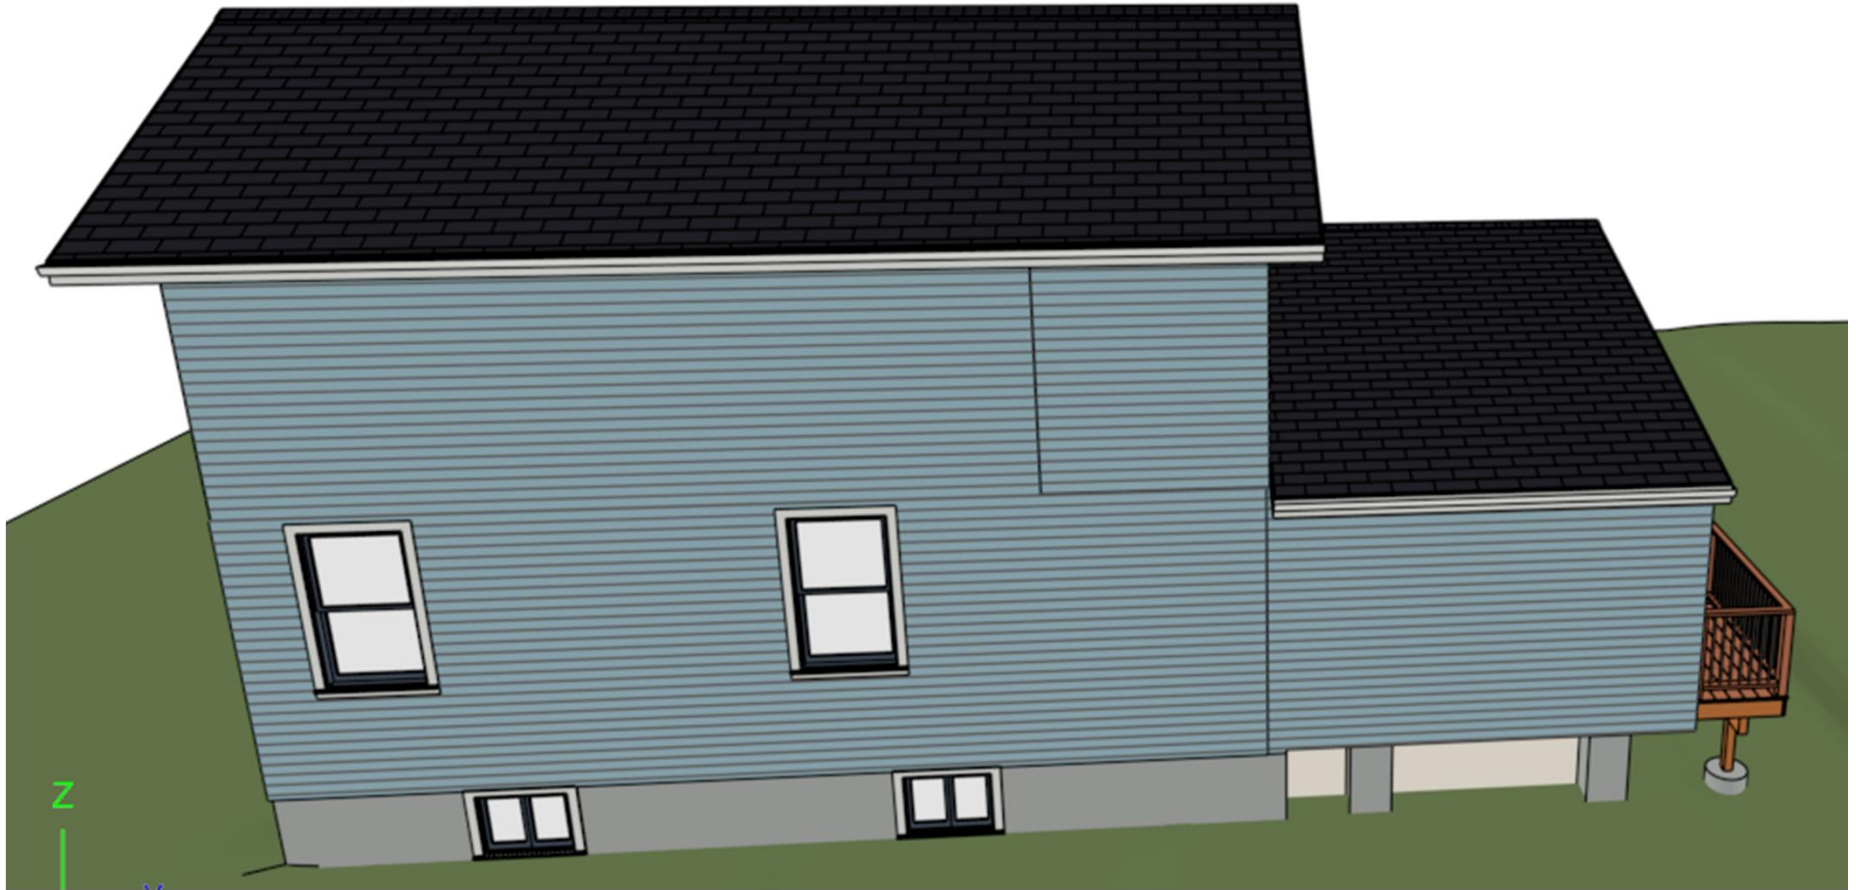
# Addition

Area to right of black lines is new construction

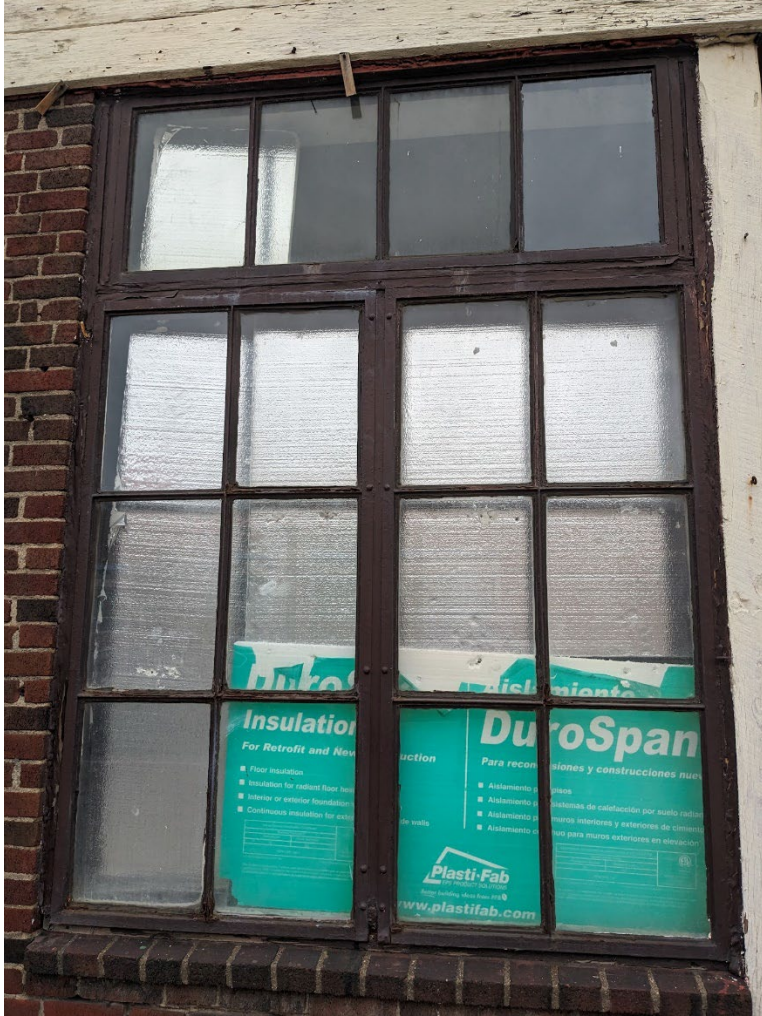
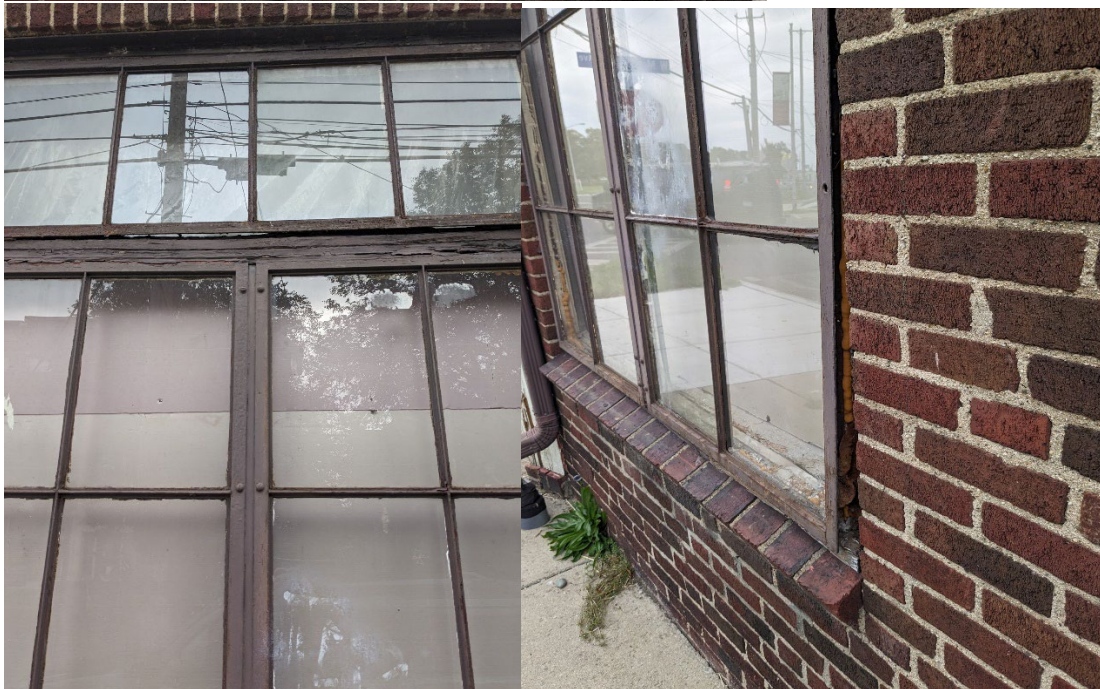
Location (1)- Page (2)

Replace large window by main door with window of same size and design, dark bronze framed thermal pane with metal insets.

Replace large window by main door with window of same size and design, dark bronze framed thermal pane with metal insets.

Windows - The windows slated for replacement are original to the structure. These windows include a window (two individual 6 lite sashes in the same opening under a 4 lite transom window) on the south side of the building (location 2), multiple windows surrounding the recessed entrance on the north side of the property (location 5), a series of three windows under transoms at the east end of the buildings north face (location 6), and a casement window (2 lite sashes in the same opening) located on the north face (location 7).

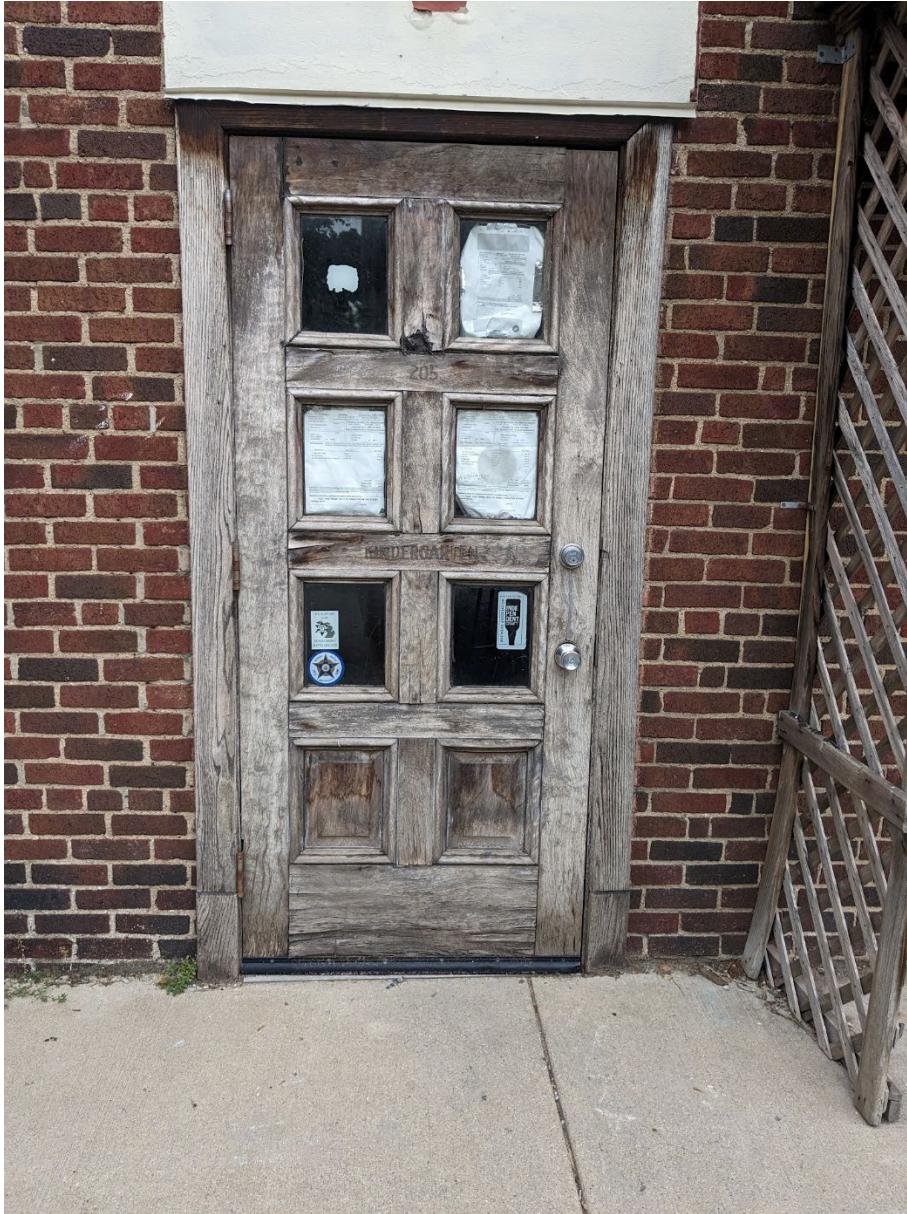
Location (2) – Page (3)

Replace dilapidated wood door with dark bronze security door, all wood trim to be replaced or reused based on wear. Opening size to remain the same.

Replace dilapidated wood door with dark bronze security door, all wood trim to be replaced or reused based on wear. Opening size to remain the same.

Doors - The doors slated for replacement are likely not historic. These doors include the entrance at the corner of Oakland and Academy (west face) and two doors on the south face (one wooden door and one metal door).

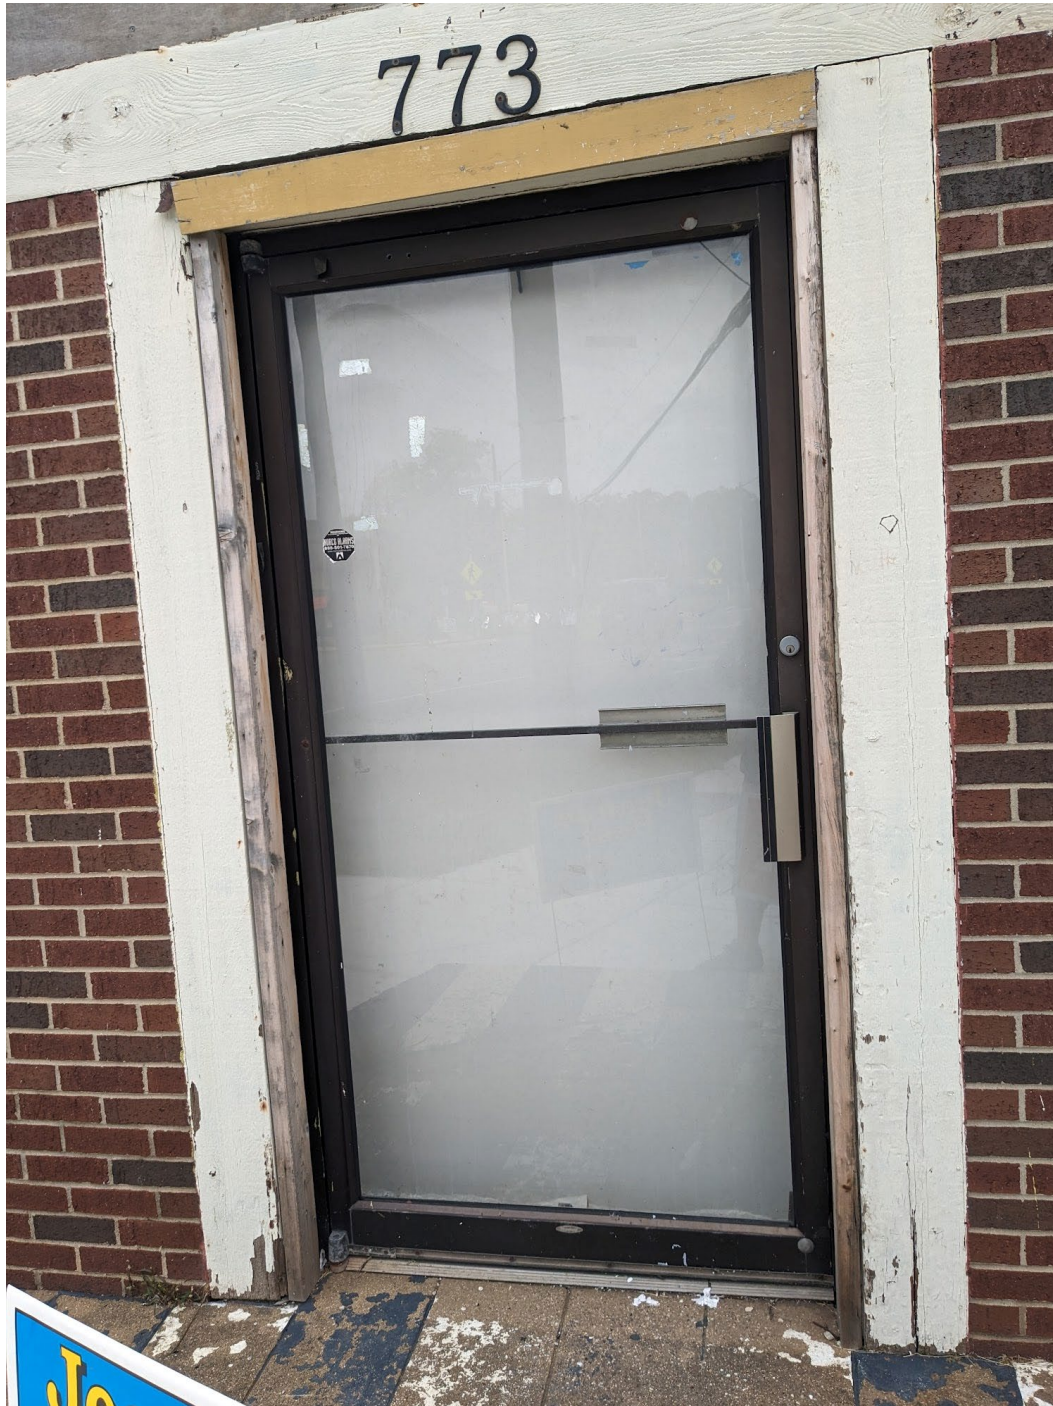
Location (3) – Page (4)

Single metal door to be replace with dark bronze double pane glass security door. Opening to remain the same and wood trim will be added at a later date when front rehabilitation work begins.

Single metal door to be replace with dark bronze double pane glass security door: Opening to remain the same and wood trim will be added at a later date when front rehabilitation work begins.

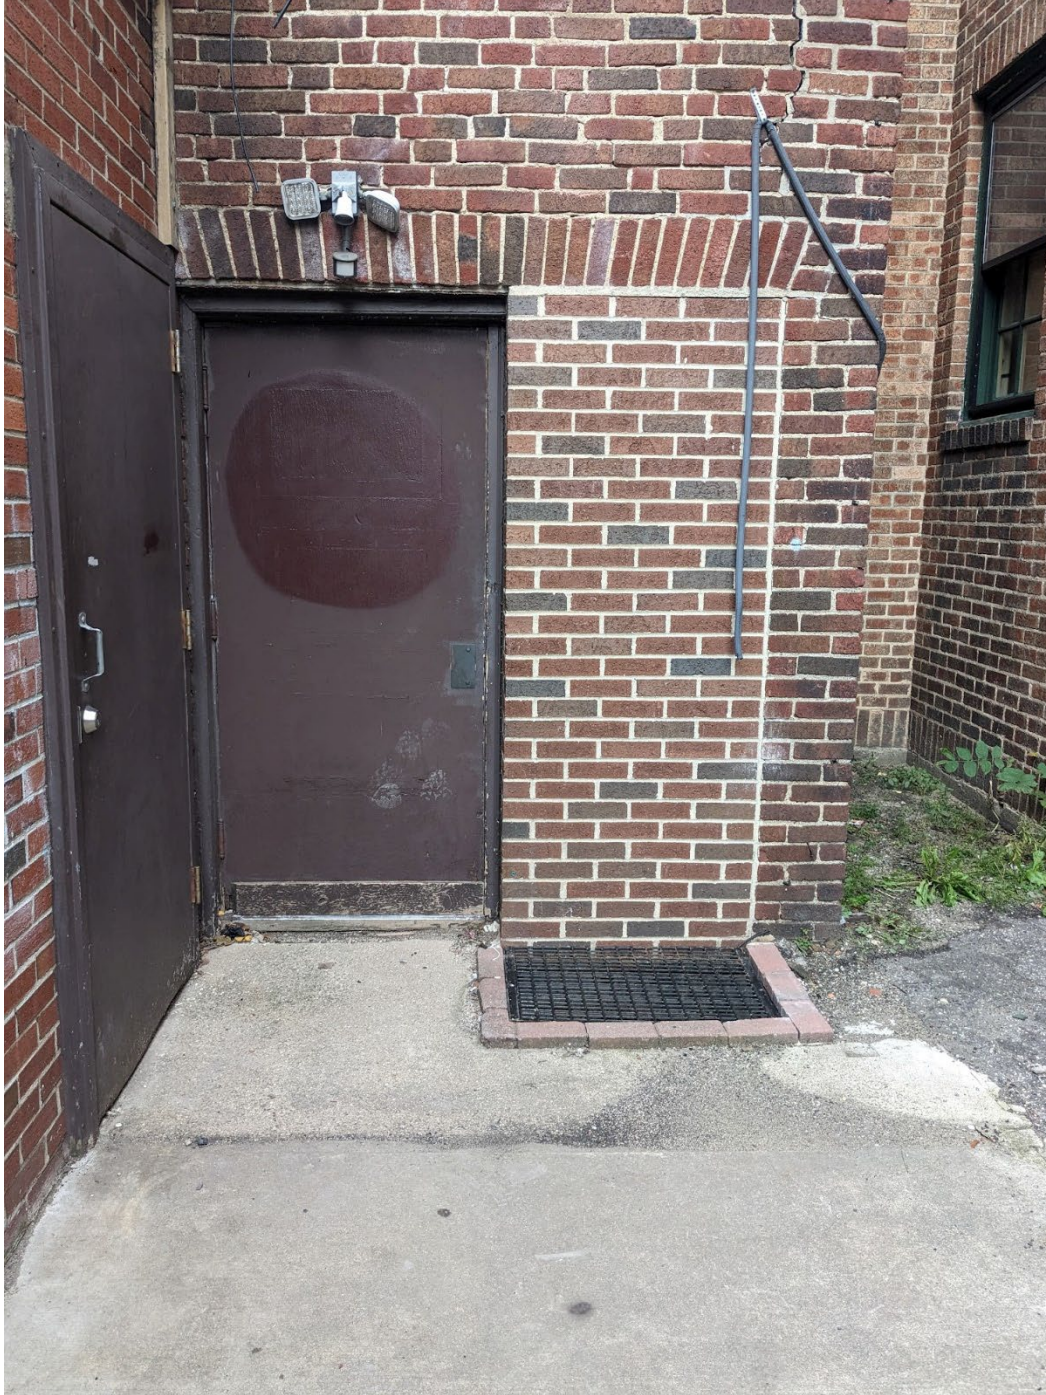
Location (4) – Page (5)

Painted security door to be replaced with solid dark bronze metal door to match other doors installed, opening to remain the same. Will be used as a main entrance into second space. Wood trim will be added to match door at Location (2).

Painted security door to be replaced with solid dark bronze metal door to match other doors installed, opening to remain the same. Will be used as a main entrance into second space. Wood trim will be added to match door at Location (2).

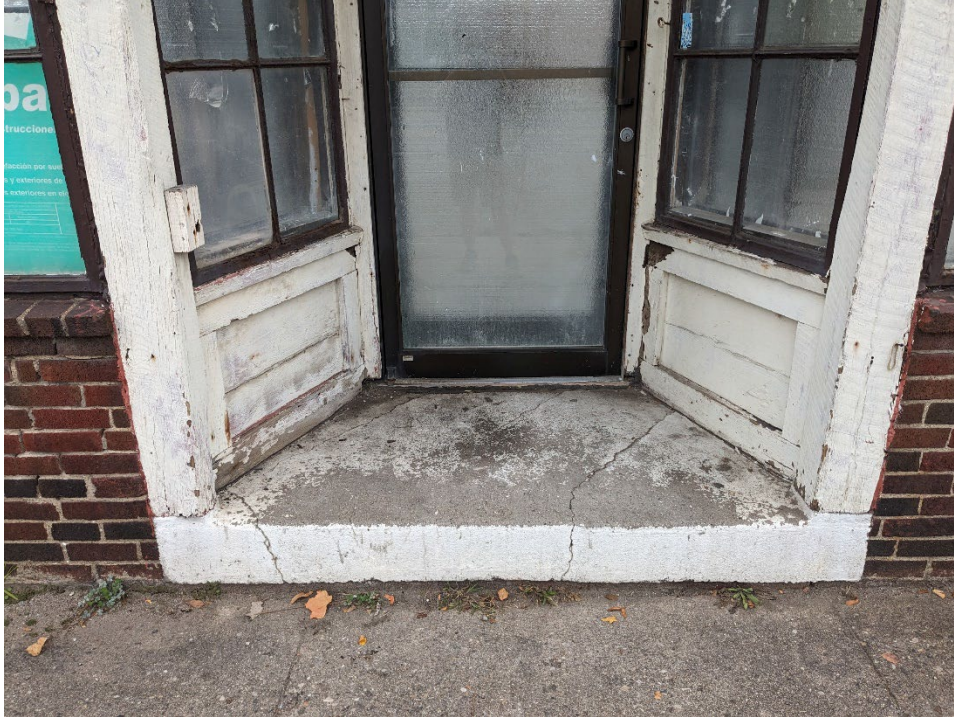
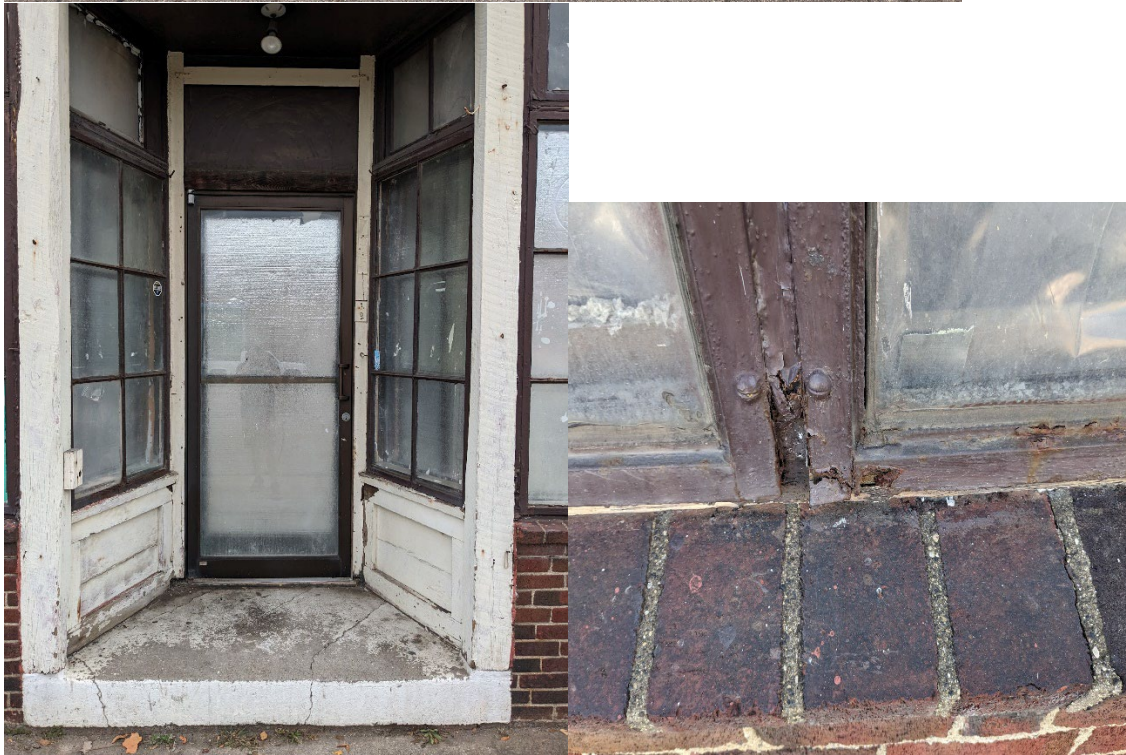
Location (5) – Page (6)

Rusted metal single pane windows will be replaced with dark bronze thermal panes. Look and size will remain the same with metal insets used in glass. Wood trim in area will be restored/replaced to maintain look.

Rusted metal single pane windows will be replaced with dark bronze thermal panes. Look and size will remain the same with metal insets used in glass. Wood trim in area will be restored/replaced to maintain look.

Windows - Some of the windows slated for replacement are designed as rusty. Without fully identifying the extent of the damage, the rust can be removed and the windows repaired. If additional damage exists that warrants the replacement of the windows, the windows should match the existing in design, color, texture and other visual qualities. The muntins in the existing windows appear to be thinner than those depicted in the renderings of the proposed windows. Furthermore, the existing muntin differ in profile from the muntins in the proposed windows.

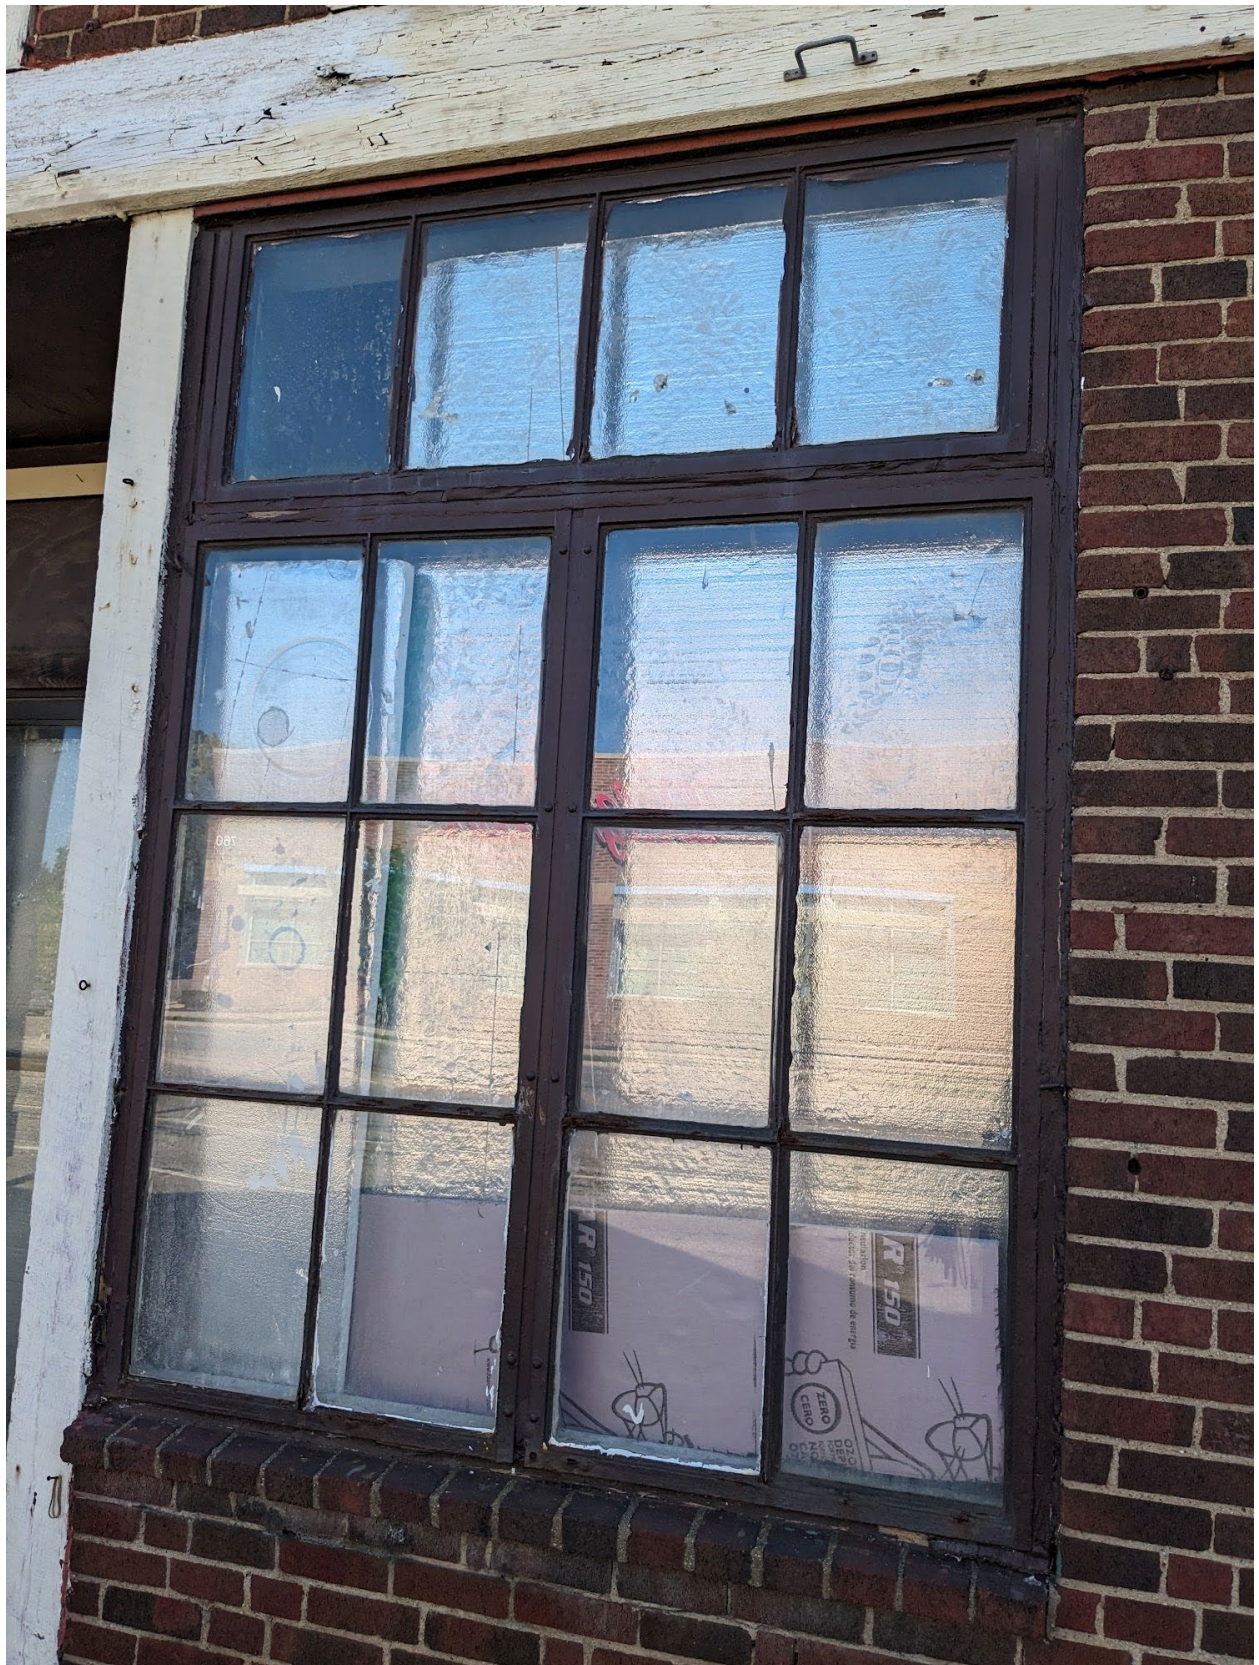
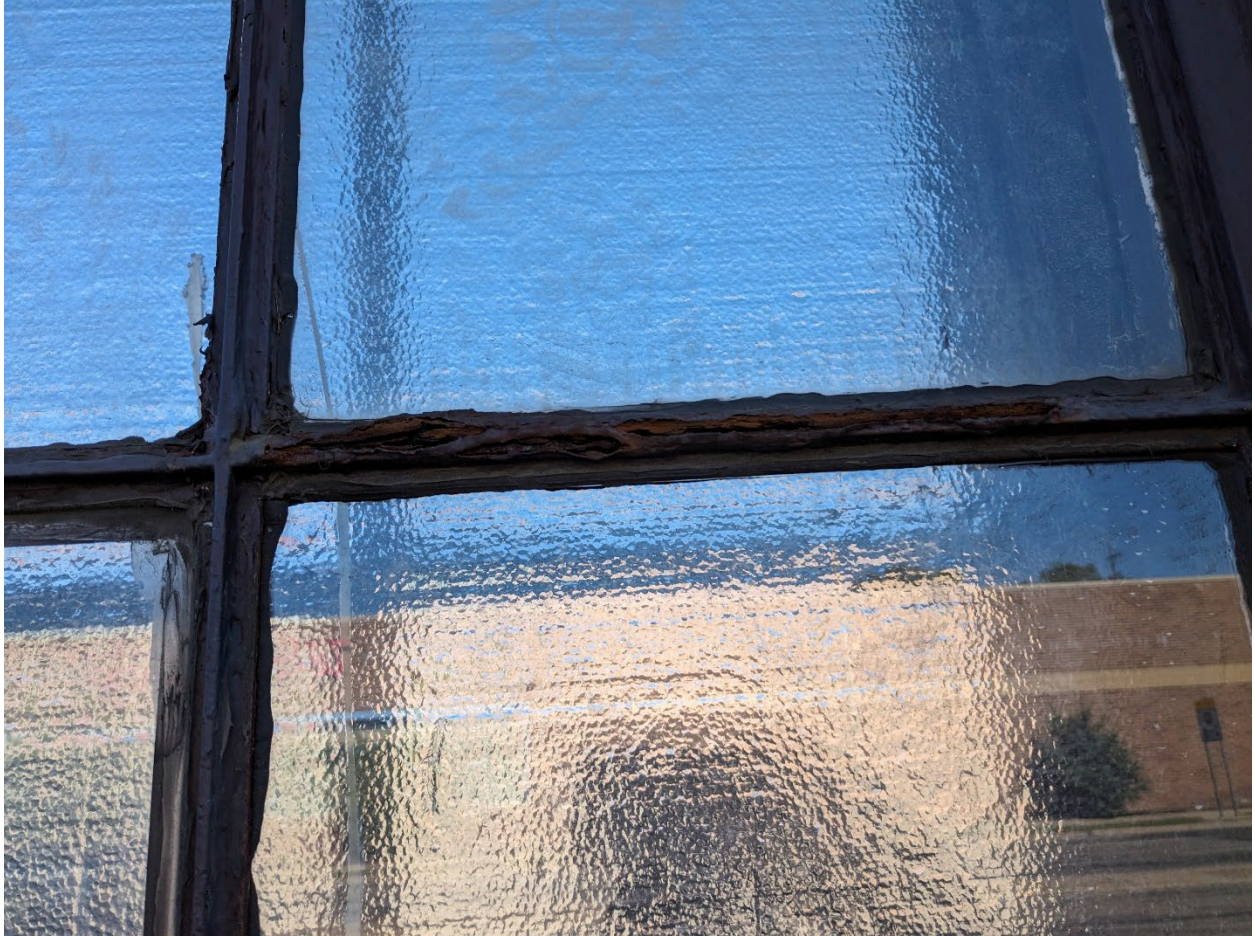
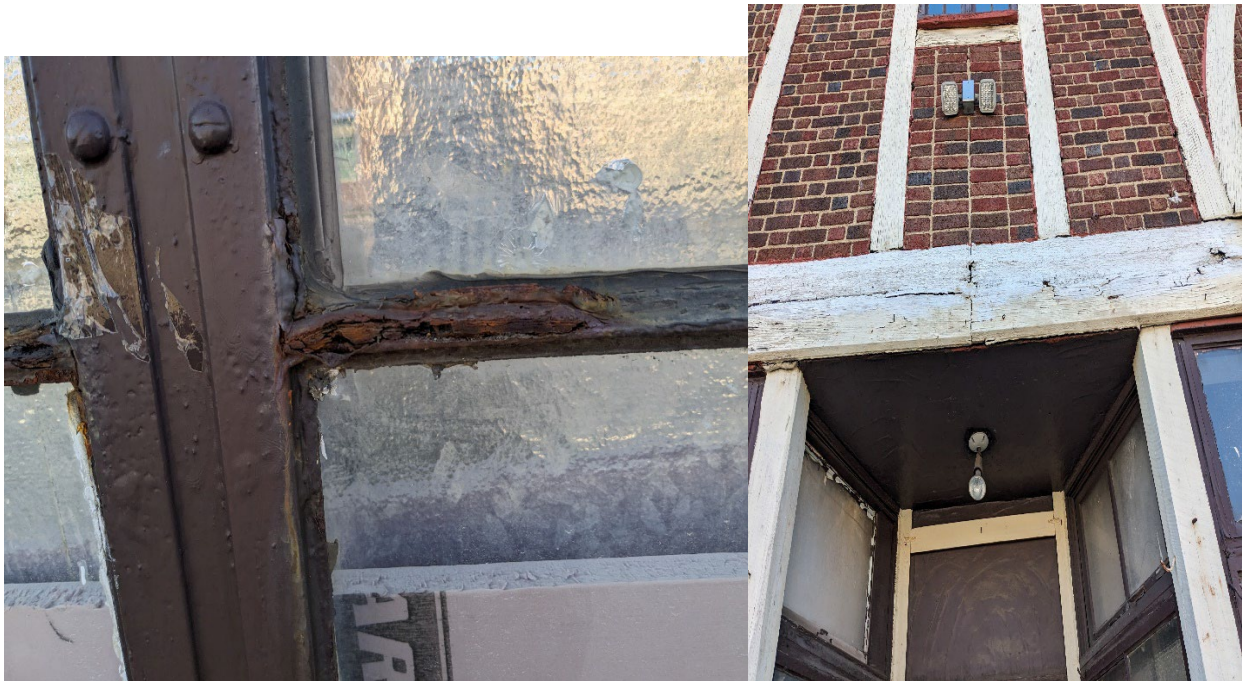
Location (6) – Page (8)

Rusted metal single pan windows will be replaced with dark bronze thermal panes. Look and size will remain the same with metal insets used in glass.

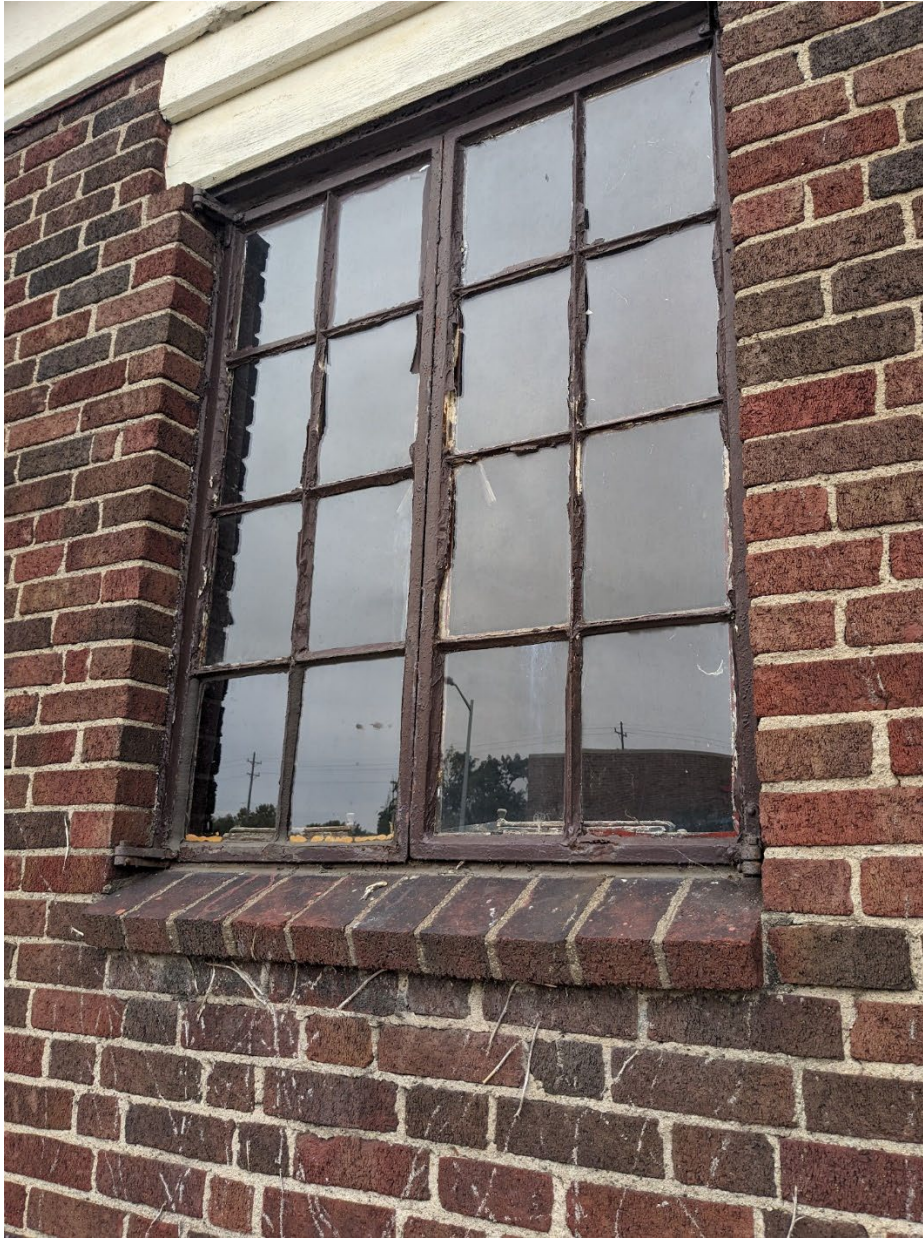
Location (7) – Page (10)

Small window will be replaced with thermal pane of same size. Metal insets not noted on design but will be added.

Small window will be replaced with thermal pane of same size. Metal insets not noted on design but will be added.

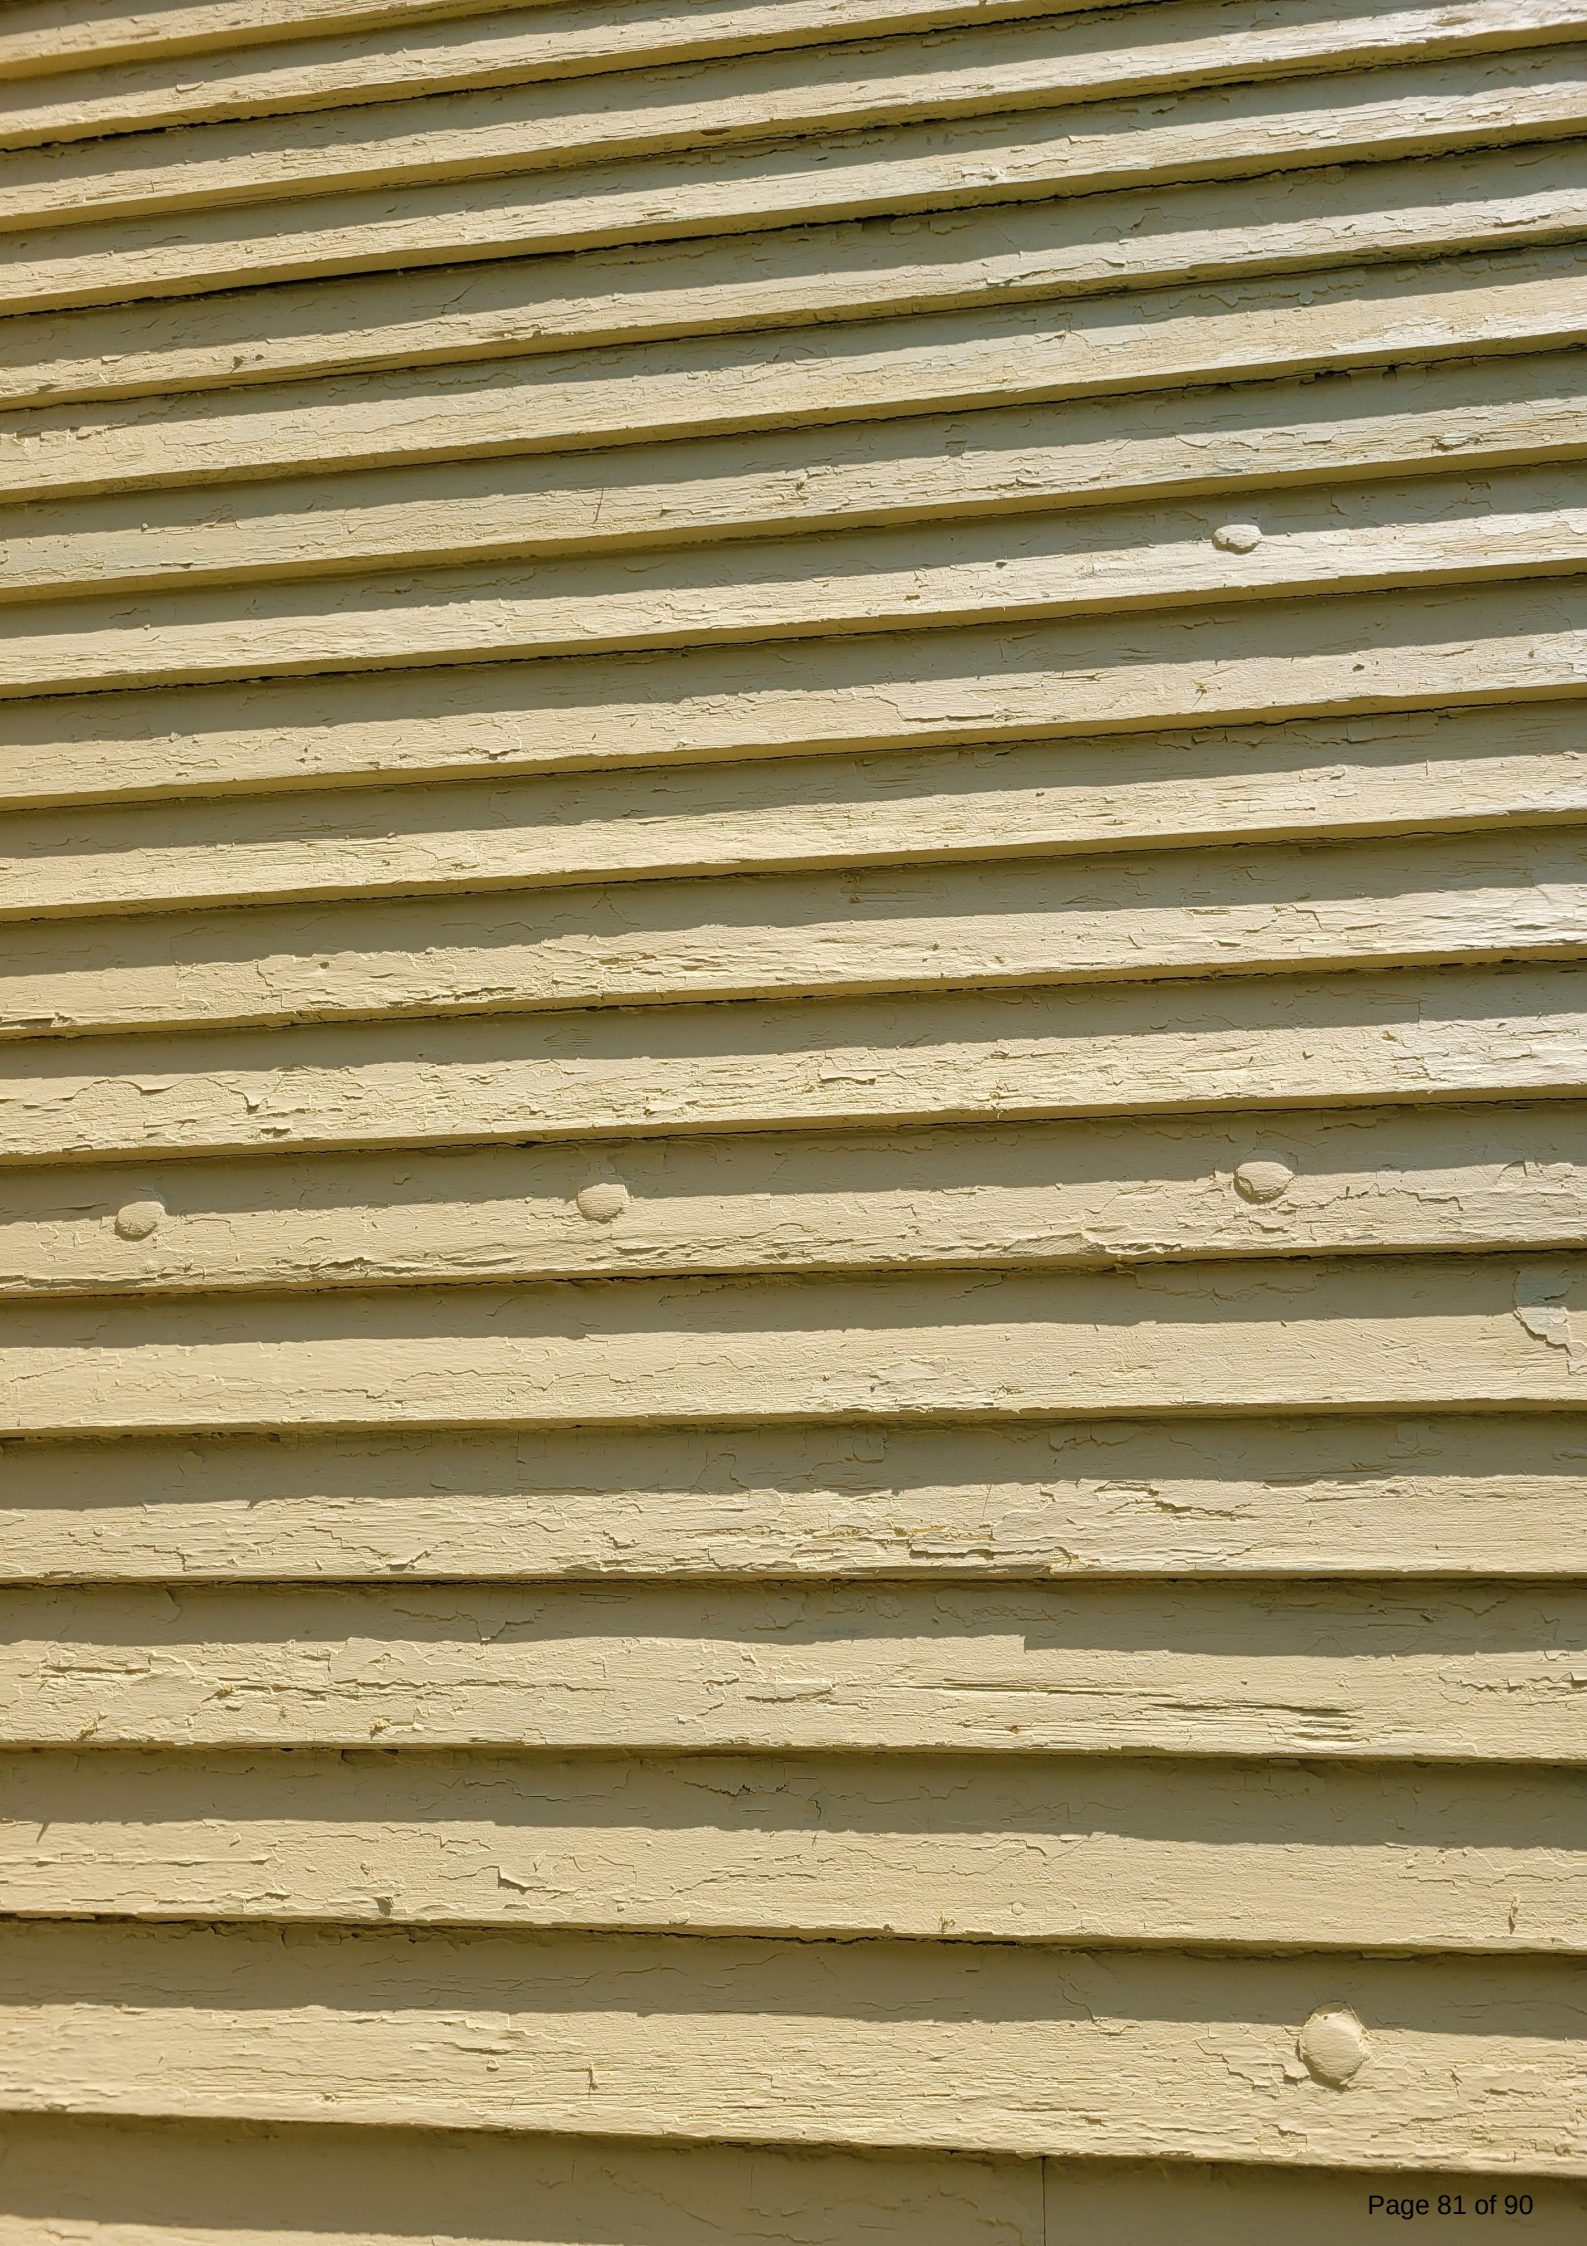
*Popping paint - new  
since last summer*
