# Agenda

## Historic District Commission

# Historic District Commission Staff Report

**SUBJECT:** 1. 1009 Oak - Alteration (Removal of one window, replacement of one window with vinyl window) PPZ25-0003 Retroactive Review

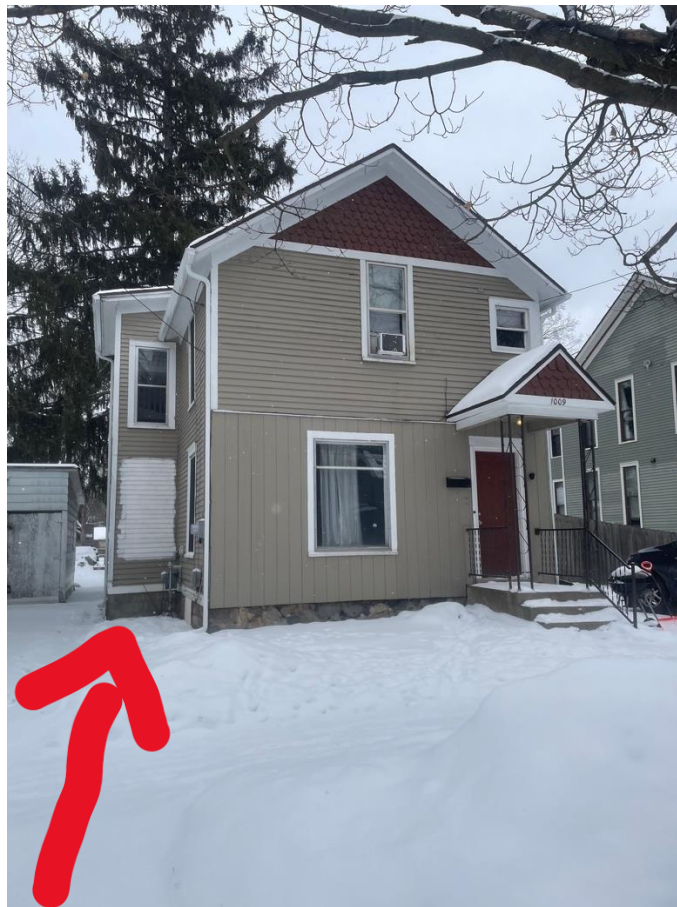
Following a service request from the tenant at 1009 Oak Street regarding the presence of mold inside the house, I engaged licensed contractor Kevin Cagney to assess the issue and recommend appropriate corrective measures.

Upon inspection, Mr. Cagney determined that both kitchen windows, along with the underlying framing, had sustained significant deterioration due to long-term water intrusion. Given the structural concerns, he recommended replacing both windows. Additionally, he advised that the window on the west side of the kitchen be enclosed with matching wood siding to mitigate ongoing moisture issues. This location has experienced persistent water intrusion for many years, likely decades, due to the original window placement.

To address the issue while maintaining the building's historic integrity, we installed appropriate clapboard wood siding in place of the window, ensuring it is consistent with the home's existing materials. The new siding has been primed, and we are awaiting approval to proceed with color-matching to seamlessly blend with the surrounding paint.

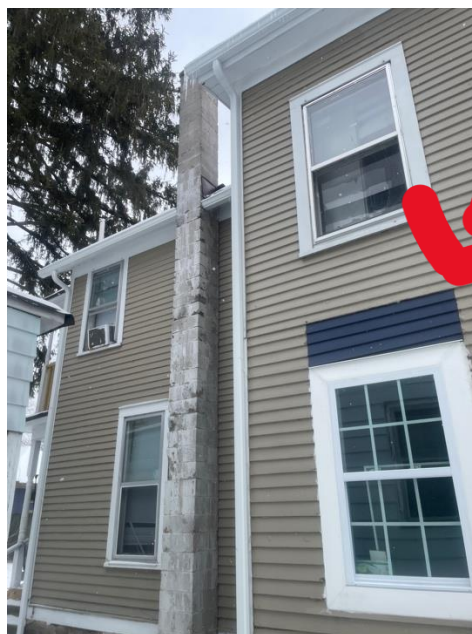
## Kitchen North Wall

The kitchen window on the north wall had deteriorated beyond repair due to extensive rot and water damage. When we purchased the property in 2017, we addressed significant water-related structural issues in this area, requiring substantial replacement of underlying materials.

To prevent future water intrusion and preserve the long-term integrity of this 150-year-old structure, we installed a new vinyl window. This decision was made to enhance durability and protect the home from further moisture-related deterioration. Given the age of the house, additional water infiltration could compromise its structural stability.

The previous window was non-standard in size, measuring 69" x 44". To ensure a secure and proper installation, we selected a slightly smaller replacement window with dimensions of 61 ½" x 42 ½". We took special care to retain the original wood framing around the window to preserve as much of the building's historic character as possible.

A small section above the window required infill with vinyl siding due to the absence of underlying structural support for wood siding in that area. Upon approval, we will color-match and paint this section to seamlessly integrate with the surrounding wood siding.

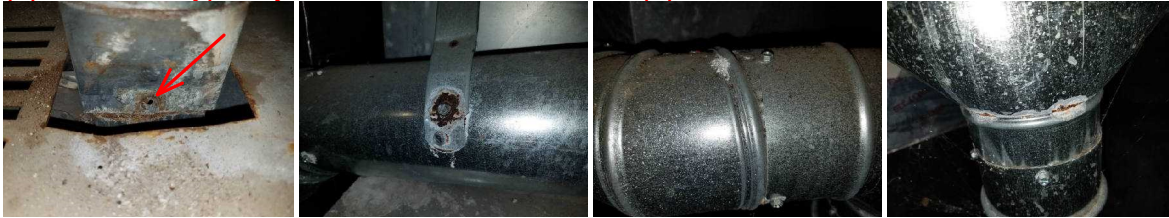
2. Heating System Flue Pipe: Single wall -
  1. The furnace flue pipe was not secured to the furnace draft blower as needed with screws.
  2. There were indications of excessive condensation (resulting in rust) in the furnace vent pipe which need further evaluation by a licensed HVAC contractor. Note that when rust is visible on the outside of a metal flue pipe, there is typically much more rust inside the pipe.

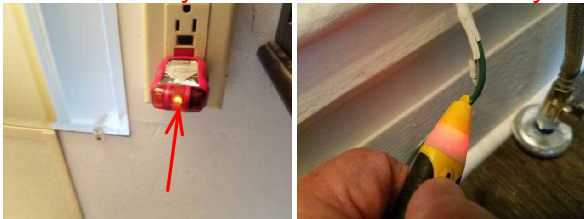
8. 2nd floor Bathroom Electrical: 110 VAC GFCI, ungrounded - 1. There was a GFCI receptacle in the bathroom, but it was not grounded. An ungrounded GFCI receptacle will provide some limited protection, but it is required to be marked as ungrounded. This receptacle was not. I recommend installing a grounded GFCI receptacle in the bathroom for safety.  
2. There was a wire hanging out of the wall behind the toilet which should be further evaluated by a licensed electrician. My tester indicated that it may be carrying current.

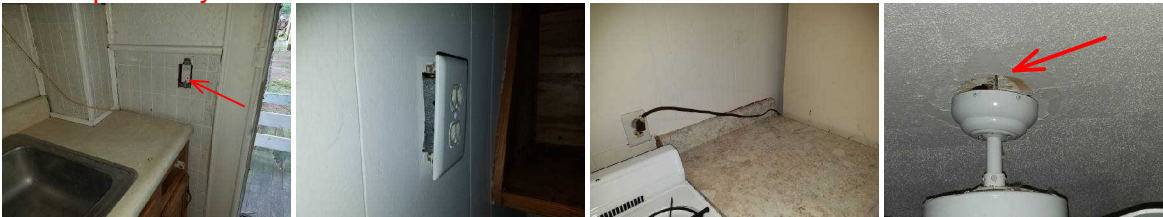
10. Kitchen Electrical: 110 VAC, Both grounded and ungrounded receptacles observed and tested - 1. GFCI protection is needed at the electrical receptacle closest to the sink, for safety (this receptacle was grounded, so it will not need to be rewired).

2. The electrical receptacle mounted high on the West wall was loose and needs proper attachment (it easily pulled out of the wall).  
3. There was no electrical receptacle behind the refrigerator. A receptacle is needed in that location.

4. The ceiling fan did not appear to be properly mounted, have further evaluated and corrected by a licensed electrician.  
Have repaired by a licensed electrician.

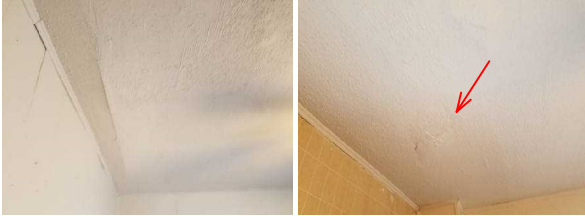
12. Kitchen Ceiling: There were a lot of cracks in the plaster ceiling and the plaster was sagging badly. Installing a new drywall ceiling would be the best way to correct this rather than attempt to repair the loose plaster (which will be temporary at best).

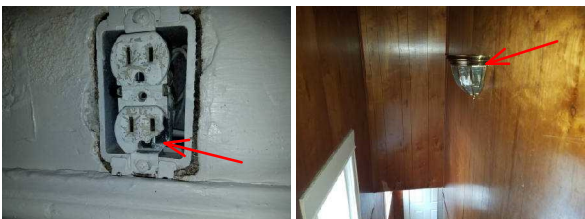
15. Living Room, Dining Room, Foyer, 1st Floor Hall, 2nd Floor Hall Living Space Electrical: 110 VAC, Both grounded and ungrounded receptacles observed and tested - 1. There was a broken receptacle below the dining room window which needs replacement by a licensed electrician. This receptacle was also missing the cover plate.

2. The light fixture above the stairs did not operate. This could be merely burned-out bulbs, but I did not have bulbs of this size to install to check.

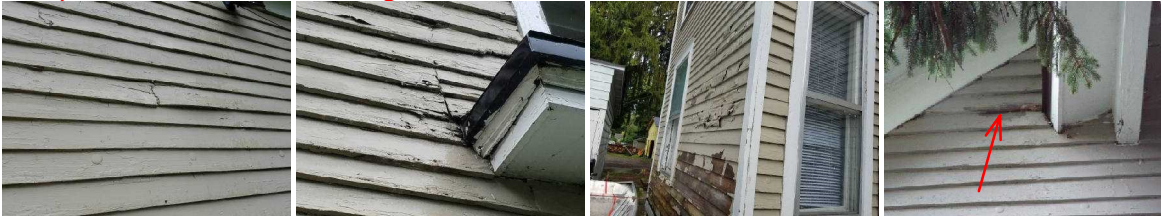
28. Exterior Surface Type: Wood - The wood siding was deteriorated in some areas. Judgements would need to be made on which pieces to replace as some siding was rotted and definitely needs replacement, while other siding was split, warped or unsightly, but may not need replacement. All of the wood siding needed scraping and painting. I did not give a cost estimate for scraping and painting of the siding. I gave a general allowance for replacement of rotted siding.

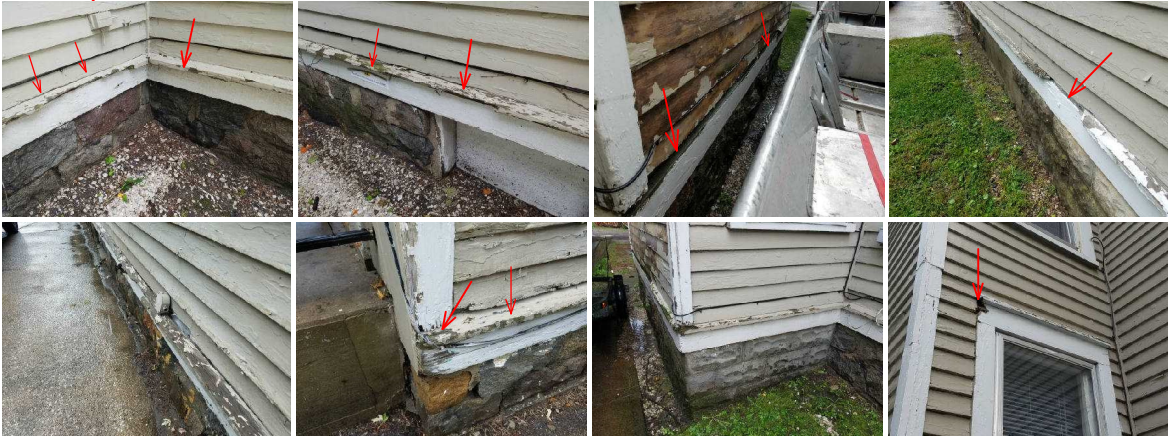
29. Trim: Wood - The wood drip cap which ran all the way around the house was in rough shape and most will need replacement. If the house is to be re sided, this will not be much of an issue.
